## CORROSION OF COATED AND UNCOATED STEEL REINFORCEMENT IN CONCRETE

Abou Shakra, Jana; Joumblat, Rouba; Khatib, Jamal; and Elkordi, Adel (2020) "CORROSION OF COATED AND UNCOATED STEEL REINFORCEMENT IN CONCRETE," *BAU Journal - Science and Technology*. Vol. 2 : Iss. 1 , Article 4.

## Abstract

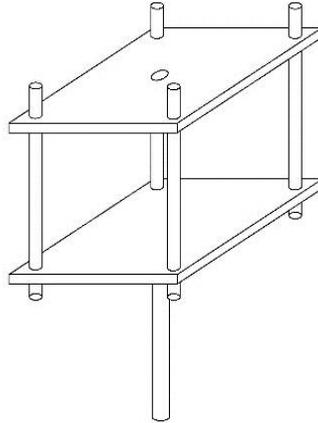
The pull out test was performed on cubes of 15 cm in size in order to assess the bond between the steel and concrete. The testing conformed to ASTM A944. Cubes were cured in water at 20C for 7 days before testing. In this test each cube was placed in a steel mould sketched in figure 1 where the load was applied axially on the steel bar and the mould. The bond strength  $\sigma_b$  was calculated by equation 1 given below .

Fig.1: Sketch of the steel mould used in the pull – out test  
Reference: Designed by the author, July 2015

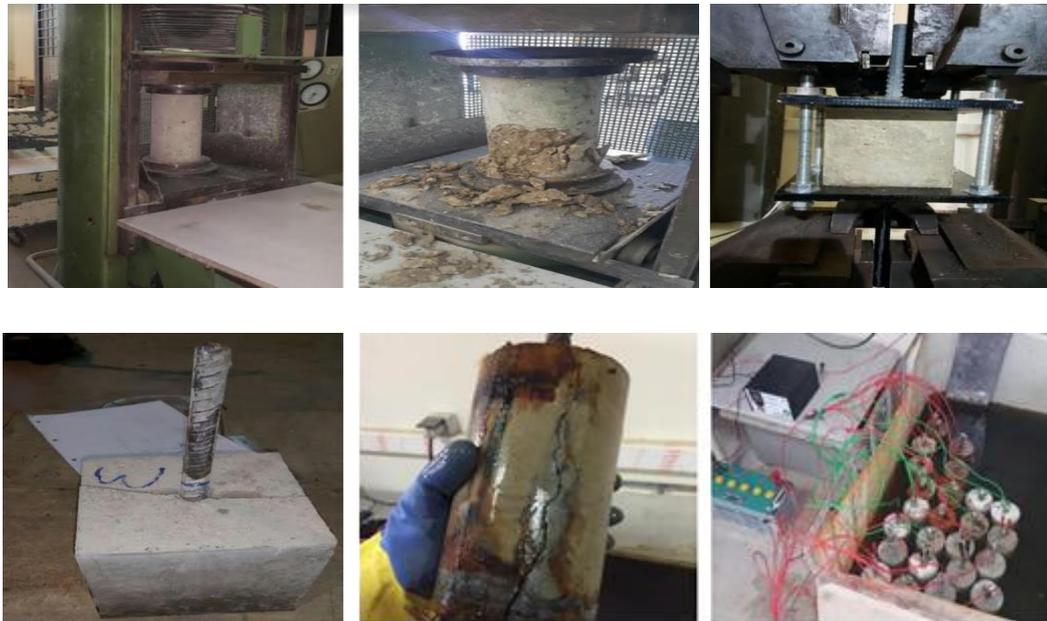
Fig.2: Compressive strength, pull out, and accelerated corrosion tests  
Reference: Photographed by the author November 2015

In this experimental study, specimens were prepared and evaluated as per relevant standards, as shown in figure 2 below.

The accelerated corrosion test was performed on eight cylindrical specimens (15cmx30cm). Two specimens contained an uncoated steel bar no. 16, two specimens contained a coated steel bar no. 16, two specimens contained uncoated steel bars no. 20, and two samples contained coated steel bars no. 20. The specimens were immersed in a 5% NaCl solution with a constant current flow through them using a portable power supply. After 7 days, all cylinders were removed for inspection of cracks. Mass loss was calculated. In addition, crack number, length, and width was also recorded to enable comparison between the specimens.

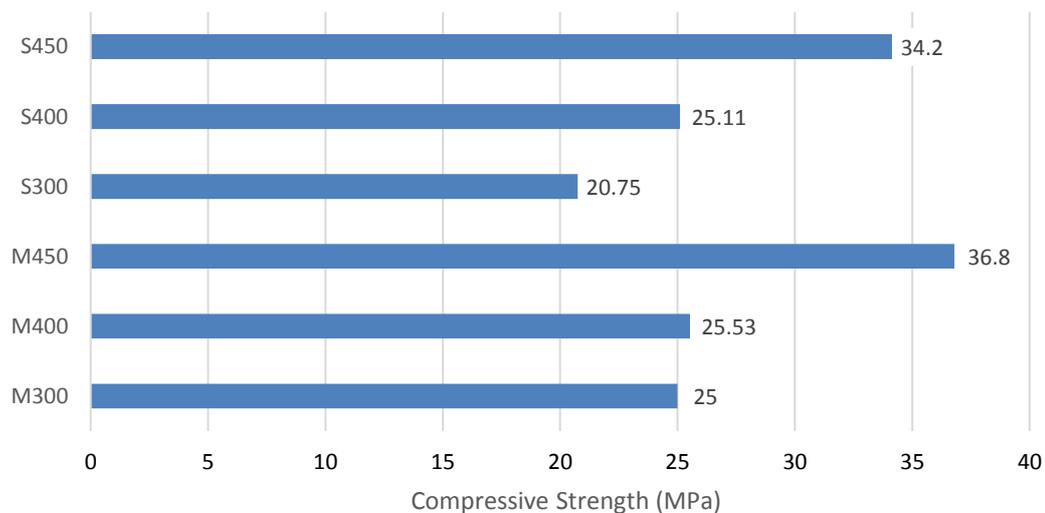
Figure 3 shows the compressive strength for the various mixes. Each value is the average of two replicate specimens. The results presented in the study are the average of these two values in Figure 3. There is a systematic increase in compressive strength as the cement or binder content in the mix increases. There is an increase of 64.82% and 47.2% when the cement or binder content varies from 300 to 450 kg/m<sup>3</sup> for mixes with and without SF respectively. Concretes containing silica fume had a lower compressive strength compared with those without SF. This is due to the higher water/binder ratio in the mixes containing silica fume of 0.5 compared with water/binder ratio of 0.4 for the other mixes.

Fig.3: Compressive strength of the different mixes at 7 days

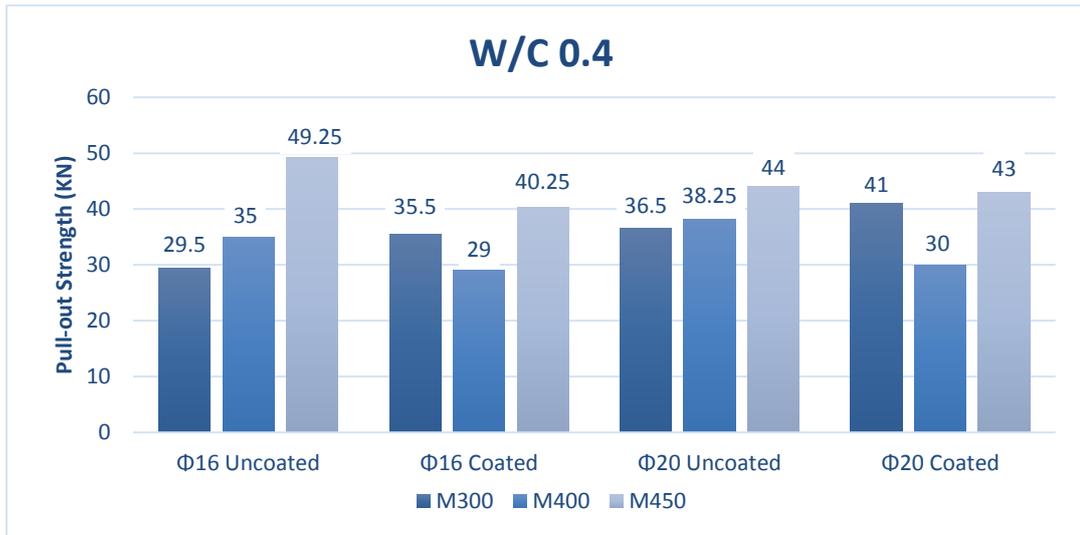
The pull-out strength of coated and uncoated bars for the various mixes are shown in Figures 4 and 5 for mixes without and with SF respectively. Two replicate specimens were tested, and the average is shown in the figures.

Mixes having cement or binder content of 300 kg/m<sup>3</sup> (M<sub>300</sub> and S<sub>300</sub>) and water/cement ratio of 0.4 and 0.5 respectively, showed similar results. The coated bars showed higher pull-out strength than those which are coated. Results show that the greater the bar diameter, the higher the bond strength. M<sub>400</sub> at water cement ratio of 0.4 scored higher pull out strengths than M<sub>300</sub> and S<sub>300</sub>. Coated samples showed lower strengths than the uncoated samples and little difference between the strengths of the samples with no. 16 and no. 20 bar diameter was detected as seen in figures 4 and 5. S<sub>400</sub> at water cement ratio of 0.5 showed lower strengths than M<sub>400</sub>. But as figures 4 and 5 show, the coated samples showed lower strength than the uncoated samples similar to M<sub>400</sub>. As concerning the mixes M<sub>450</sub> and S<sub>450</sub> at water cement ratio of 0.4 and 0.5 respectively, the samples scored the highest bond strength between all the mixes, but also the uncoated samples showed higher bond between concrete and steel than coated samples. The difference between the no. 16 and no. 20 bar diameter samples was considered insignificant.

Fig.4: Variation of pull-out strength of mixes without silica fume with respect to water cement ratio 0.4

Thus, it was inferred that mixes with the highest cement content showed higher pull-out strengths. Also, the epoxy rich in zinc coating reduced the bond between the steel bar and concrete resulting in lower pull-out strengths.

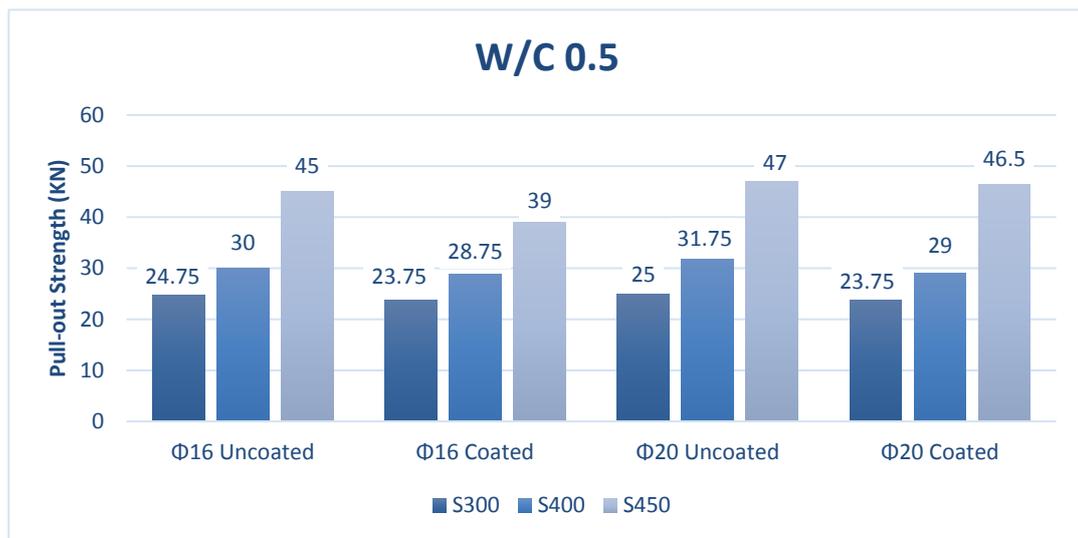
Fig.5: Variation of pull-out strength of mixes containing silica fume with respect to water cement ratio 0.5

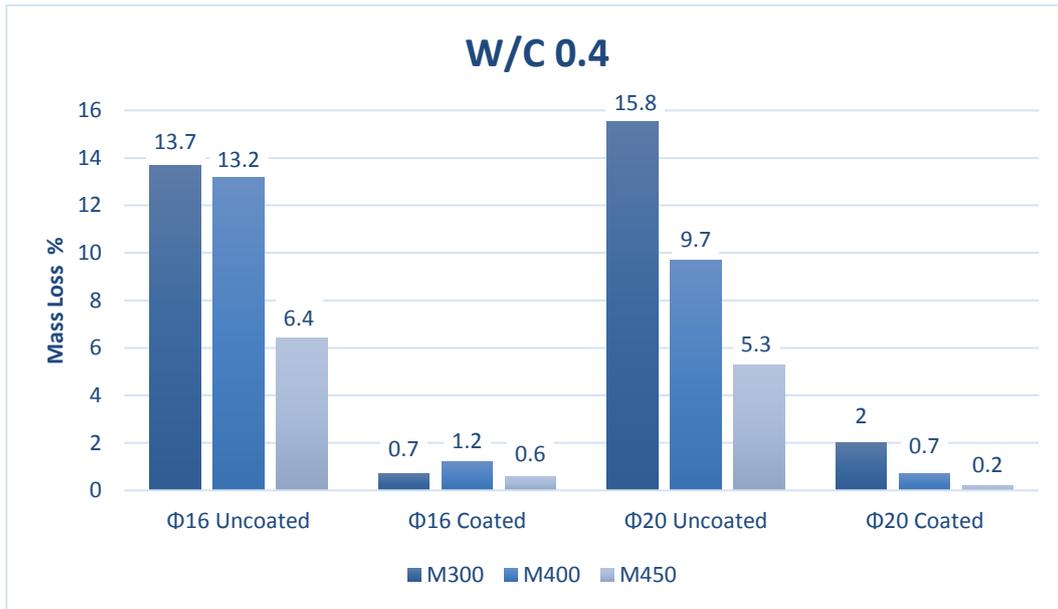
The % mass loss for different mixes M300, M400 and M450 is shown in Figure 6 and for the other mixes is shown in Figure 7. The mass loss for uncoated bars was significantly higher than those coated. However, the mass loss in coated bars is nearly negligible. The presence of silica fume in the mixes reduced the % mass loss, even though these mixes were prepared at a higher water/binder ratio.

Fig.6: Variation of mass losses of coated and uncoated steel bars at water cement ratio 0.4

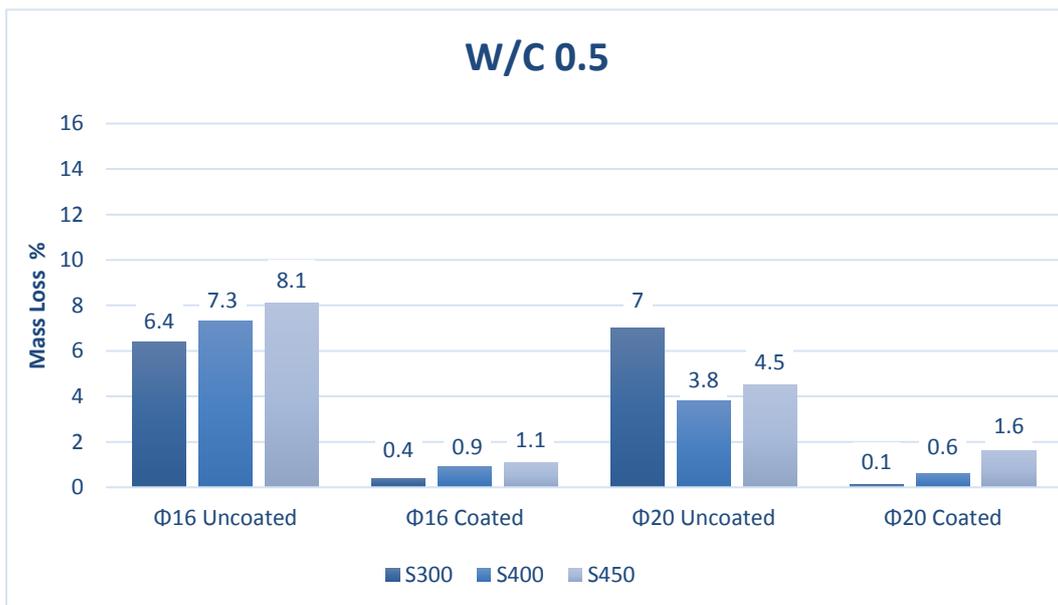
Fig.7: Variation of mass losses of coated and uncoated steel bars at water cement ratio 0.5

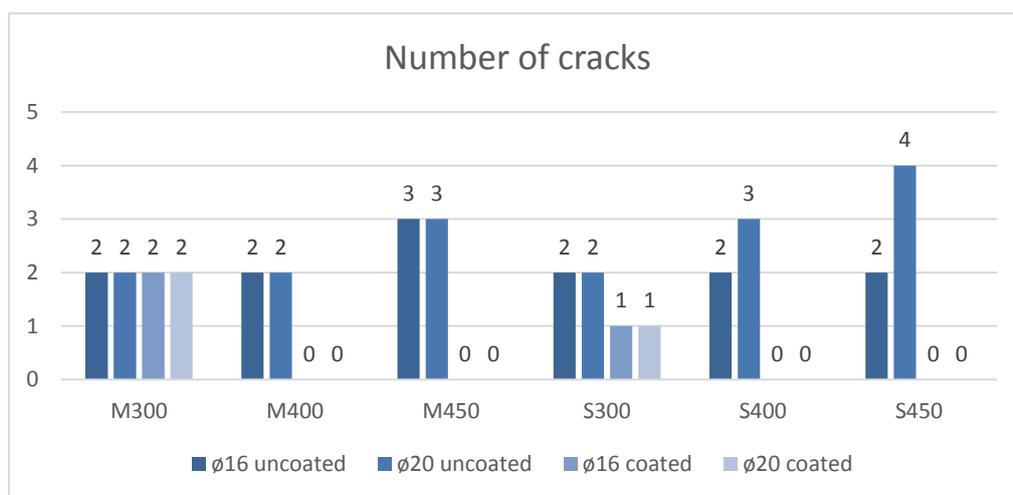
Whereas in S<sub>300</sub>, an average of two cracks in samples no. 16 and 20 uncoated each of approximate length of 19cm and crack width of 6mm, and an average of one crack was seen in the coated samples with crack length of 5cm and width of 3mm, as recorded in figure 8.

An average of two cracks was spotted in S<sub>400</sub> in samples no. 16 uncoated of approximate length of 13cm and width of 1mm, and an average of three cracks in samples no. 20 uncoated of length of 13cm and width of 1mm, whereas in the uncoated samples, no cracks were seen, as shown in figure 8.

Fig.8: Variation of crack number in each sample of the different mixes

Two cracks were observed in M<sub>300</sub> in average for each of samples no. 16 and 20 uncoated each of approximate length of 16cm and width of 3mm, and only fine cracks were spotted in samples no. 16 and 20 coated of length of 3cm and width of 0.2mm.

An average of two cracks was spotted in M<sub>400</sub> in no. 16 and no. 20 uncoated samples of approximate length 13cm and width 1mm, whereas in the uncoated samples, no cracks were spotted .

Three cracks in average were seen in M<sub>450</sub> for each of samples no. 16 and 20 uncoated of length of 10cm and width of 1mm, and no cracks were spotted in samples no. 16 and 20 coated. Whereas, an average of two cracks was spotted in S<sub>450</sub> in samples no. 16 uncoated of length of 9cm and width of 1mm, and an average of 4 cracks in samples no. 20 uncoated of length of 8cm and width of 0.5mm, whereas in the uncoated samples, no cracks were seen.

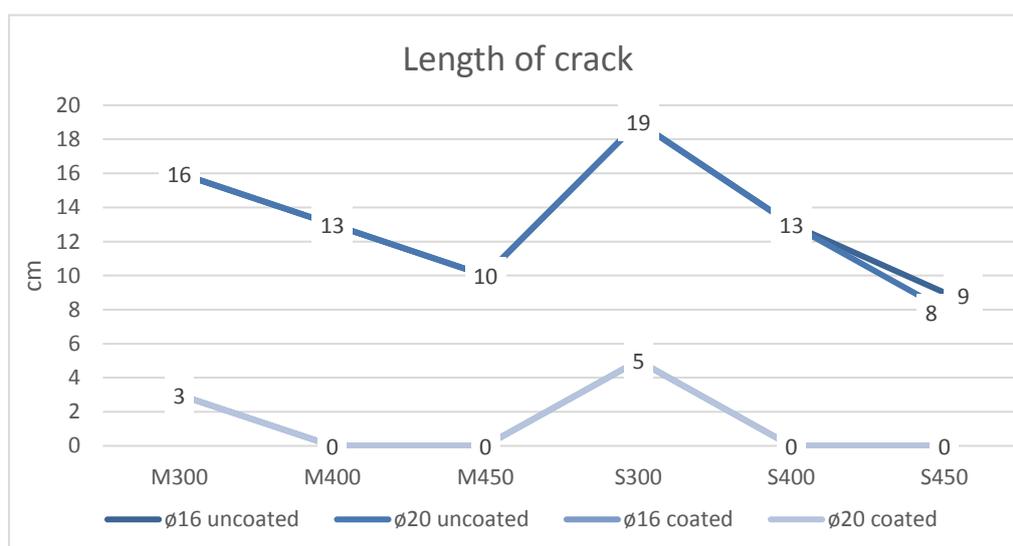
Fig.9: Variation of crack length in each sample of the different mixes

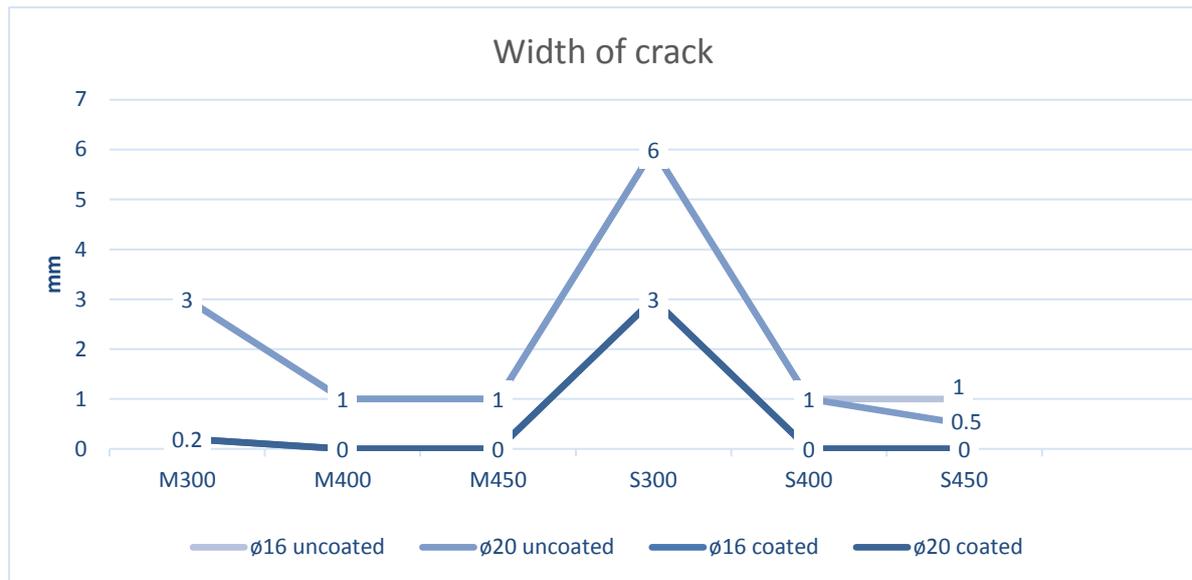
Fig.10: Variation of crack width in each sample of the different mixes
